Metal chimney boxes, painted to look like brick and mortar

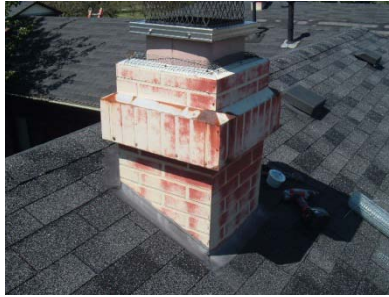
Is your chimney similar to this style?

If so, there is a pretty good chance that you have a potential problem that can lead to a house fire.

Many of these air cooled chimneys with metal chimney chase had an engineering flaw that allowed birds and or squirrels to enter the box and outer triple wall chimney pipe.

Screening the center pipe or capping as in above photo, only screens one out of three possible entry areas into this chimney system.

The other areas lead not only into the triple wall system and metal chimney chase, but into the attic or crawl space as well!

The nesting not only adds a combustibile material to the chimney system, but also shuts down the ability for the air cooling mechanism to work. MANY houses have burned down through the entire United States due to this flaw

In some cases, we can remove reachable nesting, and properly screen to eliminate future nesting.

In others, when nesting cannot be removed, the entire system would need to be removed and replaced.

Adding gas logs to this style fireplace without a thorough inspection above the roofline can be a very bad idea.
